# Final Environmental Assessment

## San Antonio Creek Restoration

### Vandenberg Air Force Base California

**8 September 2008**

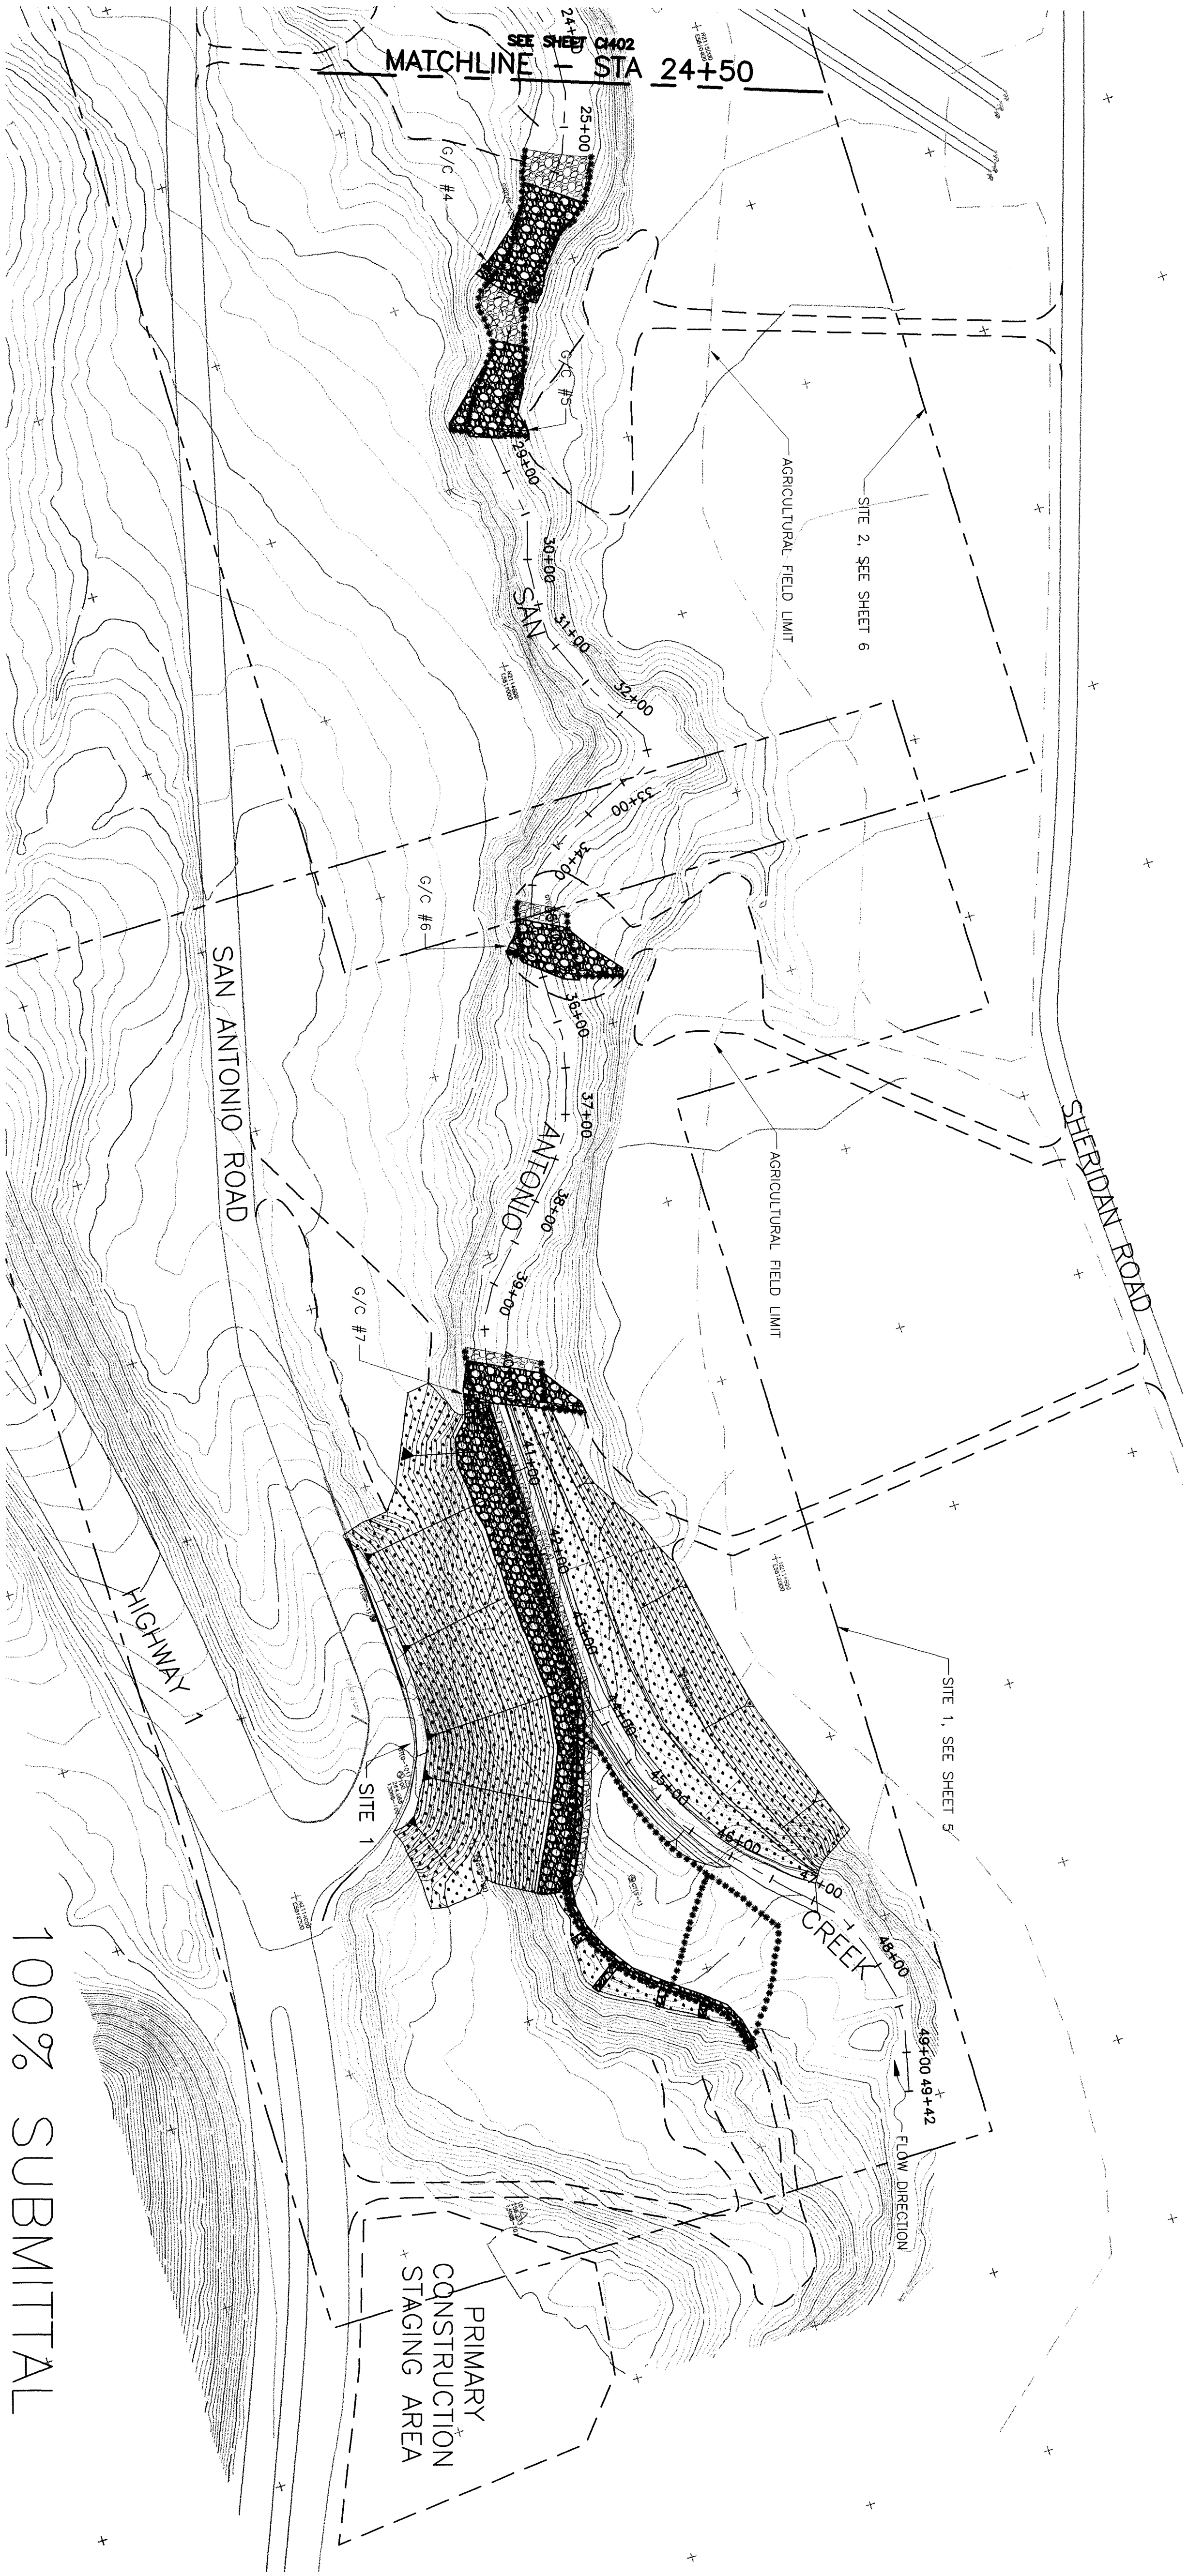
GENERAL PLAN

NOTES:  
1. LONGITUDINAL STRUCTURES AND TOP OF CHANNEL STATIONING SHOWN  
2. PROPOSED PERMANENT CHANNEL CENTERLINE  
3. FOR EXACT LOCATION AND HEIGHT OF LONGITUDINAL STRUCTURES, SEE  
SHEETS 5, 6, AND 7. SOME ELEVATIONS MAY NEED TO BE FIELD  
CHECKED.  
4. GRADE CONTROL ROCK IS SHOWN ALONG CENTERLINE PROFILE. KEY  
ROCK (TO 100-YEAR MSE) NOT SHOWN.

PROFILE STATION 24+50 TO 50+00

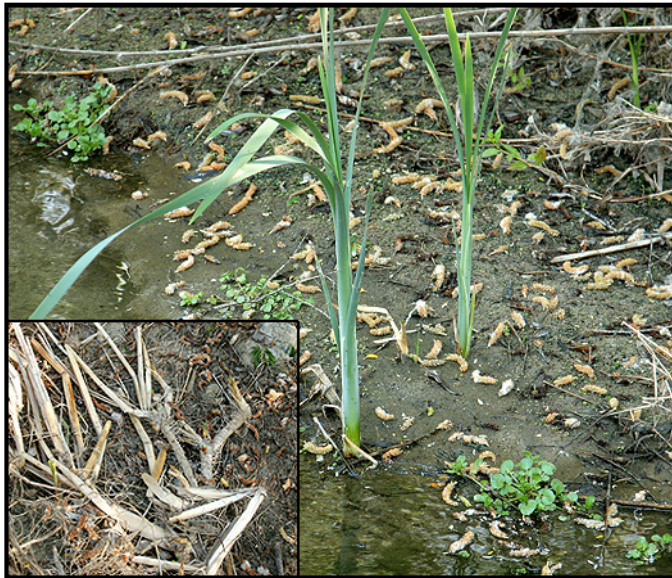
Figure 2. *Typha* sp. and *Rorippa nasturtium-aquaticum*, watercress, recolonizing creek bank. Inset: *Typha* sp. resprouting from exposed rhizome.

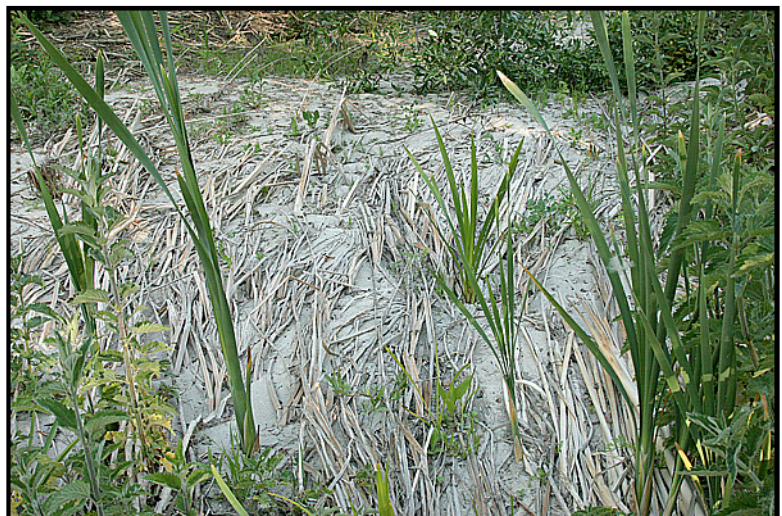
Figure 3. Vegetation bent from previous flow events provides evidence of drainage patterns in wetlands.

Wetland hydrology was the most conserved wetland parameter. Drift lines, and drainage patterns in wetlands were the most common and extensive primary indicators of wetland hydrology. Along the main creek channel where steep banks are present, pronounced shelving is also present indicative of flow. In areas where the creek is bordered by rip-rap or shear cliffs, water staining is the primary indicator of wetland hydrology.

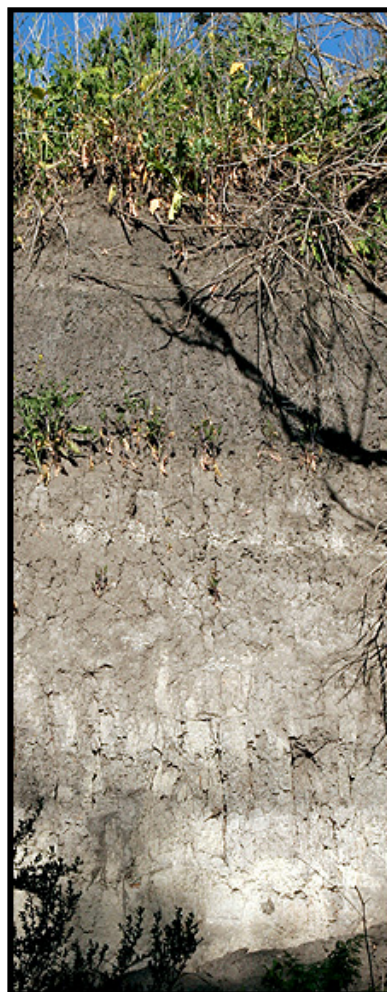
Figure 4. The dark upper layer visible on this eroding cliff face is a silty clay loam reflective of relic hydric conditions

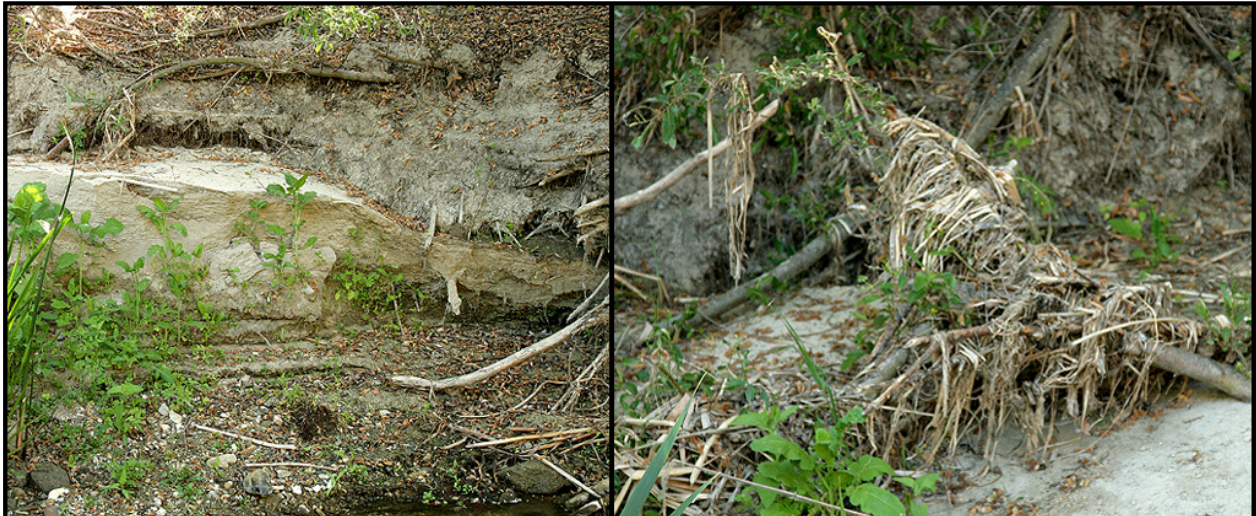
Figure 5. Shelving on the bank (left) and sediment deposits (right) were two features used to determine the OHWM.

The boundaries of Waters of the United States include areas encompassed by the OHWM of San Antonio Creek, wetlands adjacent to the San Antonio Creek channel, and areas bound by the San Antonio Creek channel. Near average rainfall levels in the 2007-2008 rainy season indicate that the OHWM established during that rainy season is likely reflective of normal circumstances. A total of 4.75 acres within the project area constitute Waters of the United States. Map 7 illustrates the extent of the Waters of the United States within the project area.
